Navajo Abandoned Uranium Mine

Site Screen Report

Mine Name: Tom Wilson
Mine IDs: 75, 76, 400, 402

August 2011

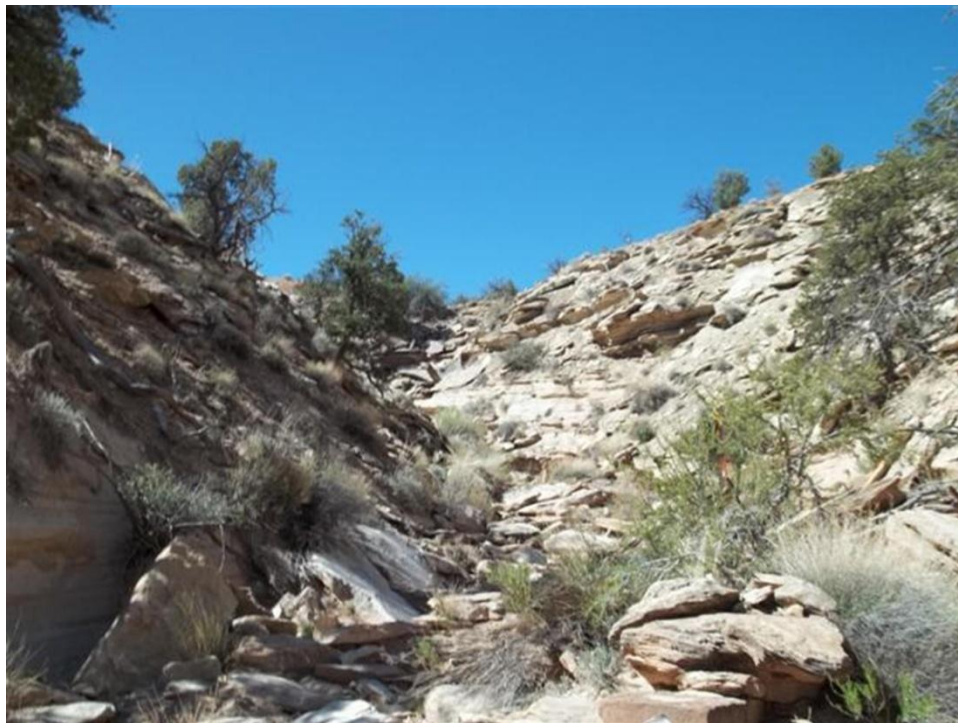
Photo 1: Mine Site #75; Onsite drainage

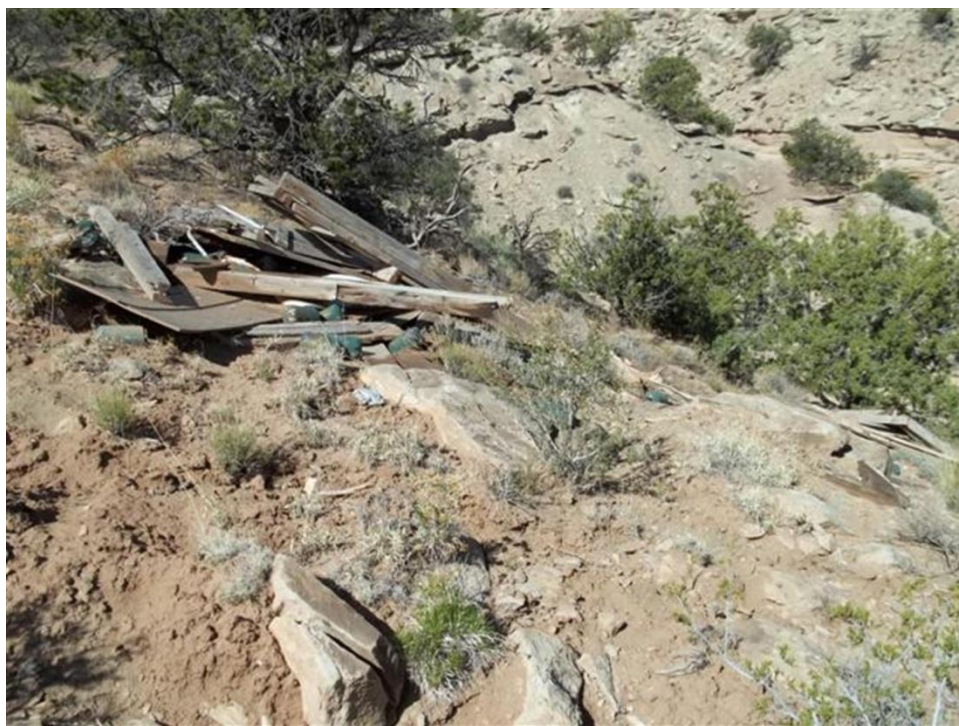
Photo 6: Mine Site #76; Potential Mining Debris

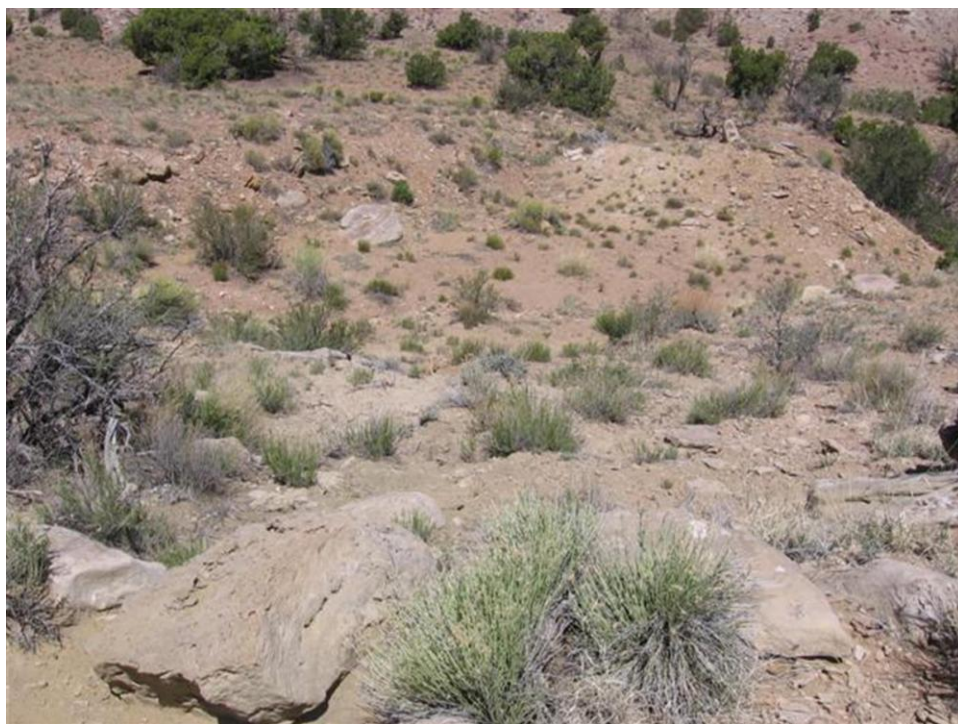
2 possible mining pits: Pit 1 - 12' diameter, surrounded by small piles of rock debris, tan-yellow sandy soil; Pit 2 - 15' diameter surrounded small piles of rock debris, tan-yellow brown sandy soil

Photo 9: Mine Site #400; Small depression

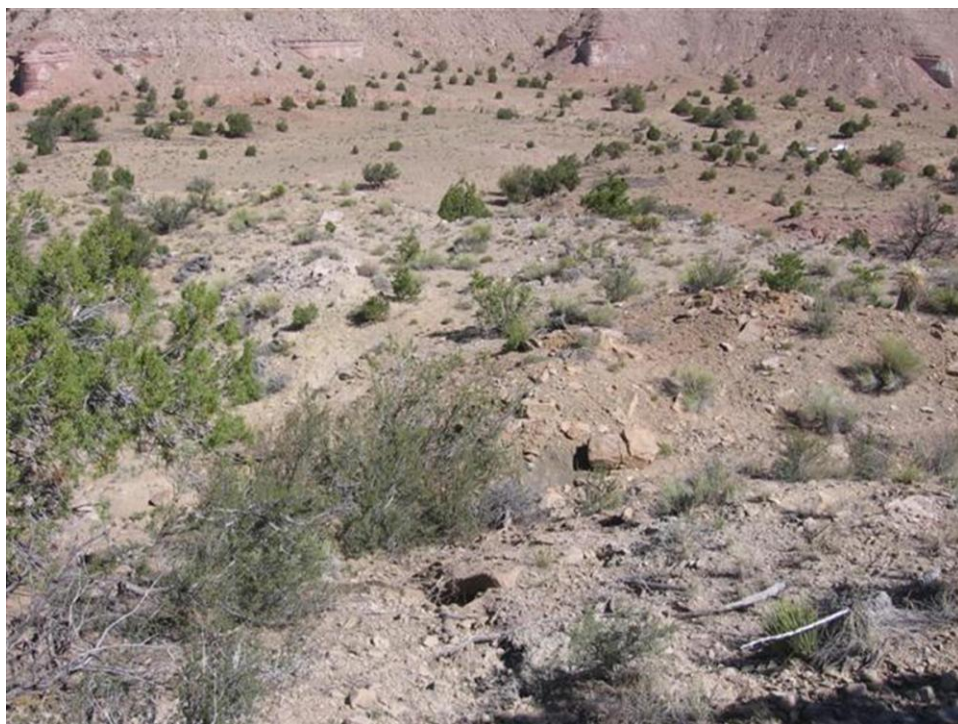
5 waste rock piles: Pile 1 - 10'x5'x3', tan light gray rocky soil, near depression area; Pile 2 - 10'x5'x3', tan light gray rocky soil, near depression area; Pile 3 - 10'x5'x3', tan light gray rocky soil, near depression area; Pile 4 - 10'x5'x3', tan light gray rocky soil, near depression area; Pile 5 - 10'x30'x6' oval, tan-gray soil with small rocks, adjacent mining road, small rock wall present 15' WSW of small depression

Photo 11: Mine Site #402; Waste piles

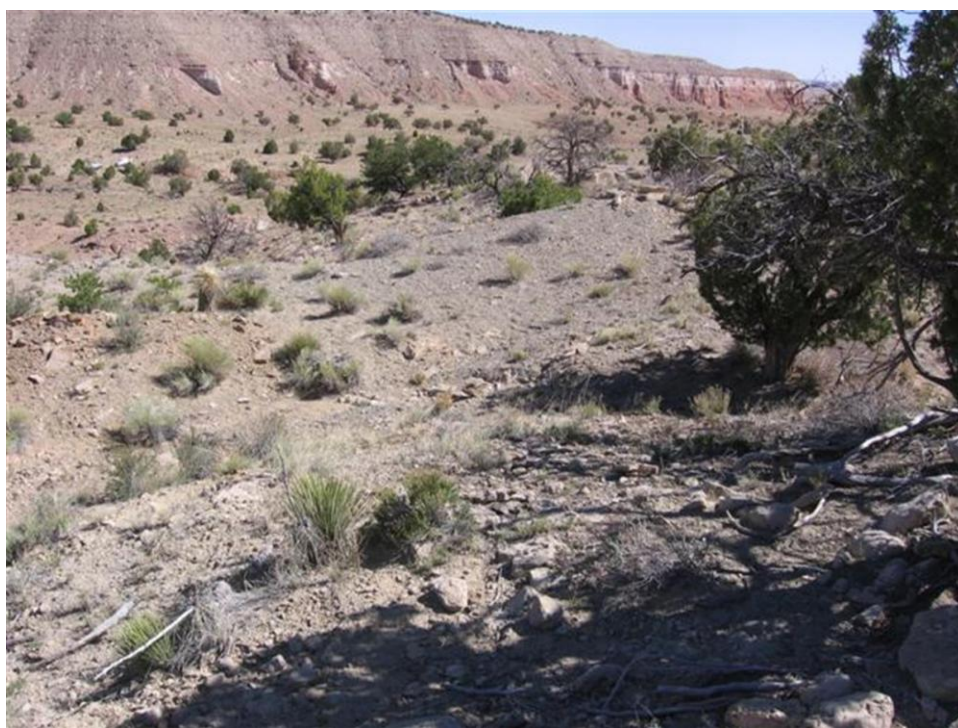
Photo 12: Mine Site #402; Waste piles

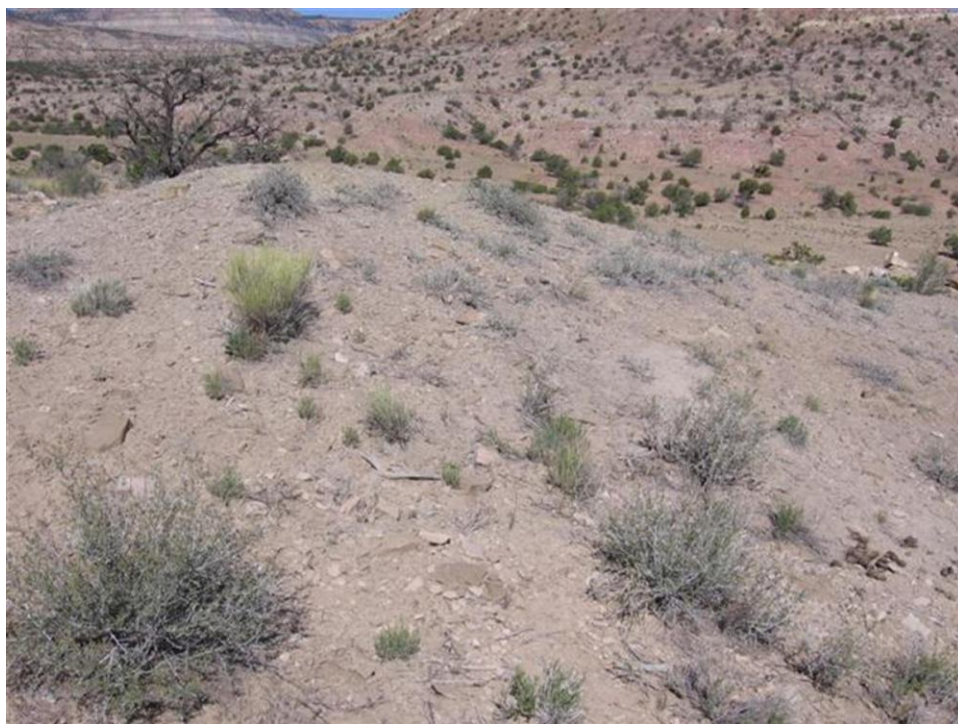
Photo 13: Mine Site #402; Waste pile

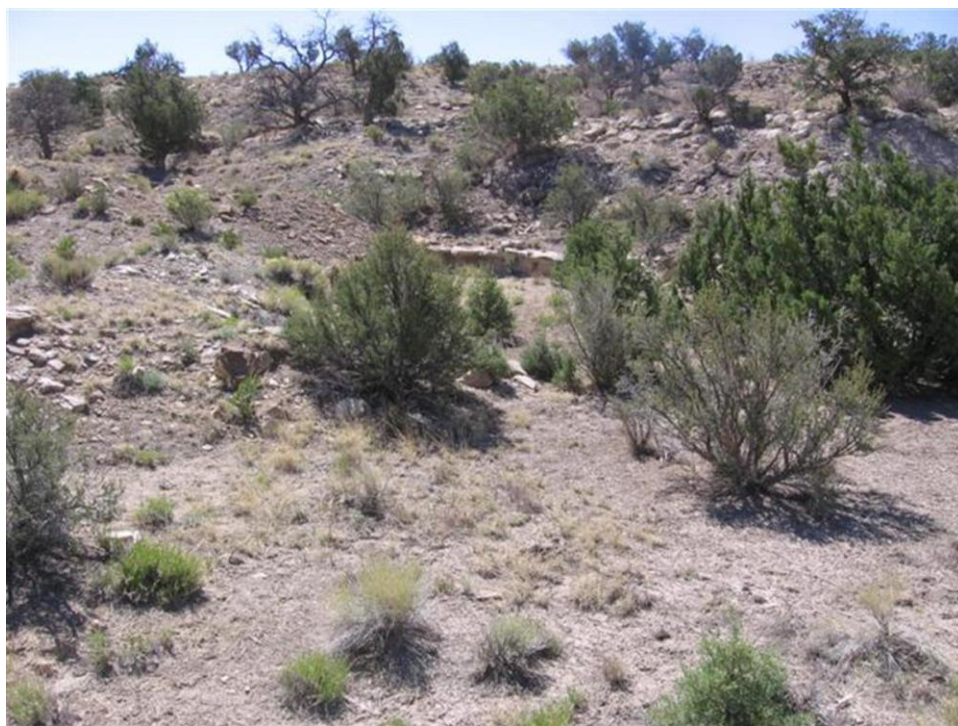
Small pit, 40' diameter, sandy bottom, surrounded by piled berms

Photo 14: Mine Site #402; Depression / piles

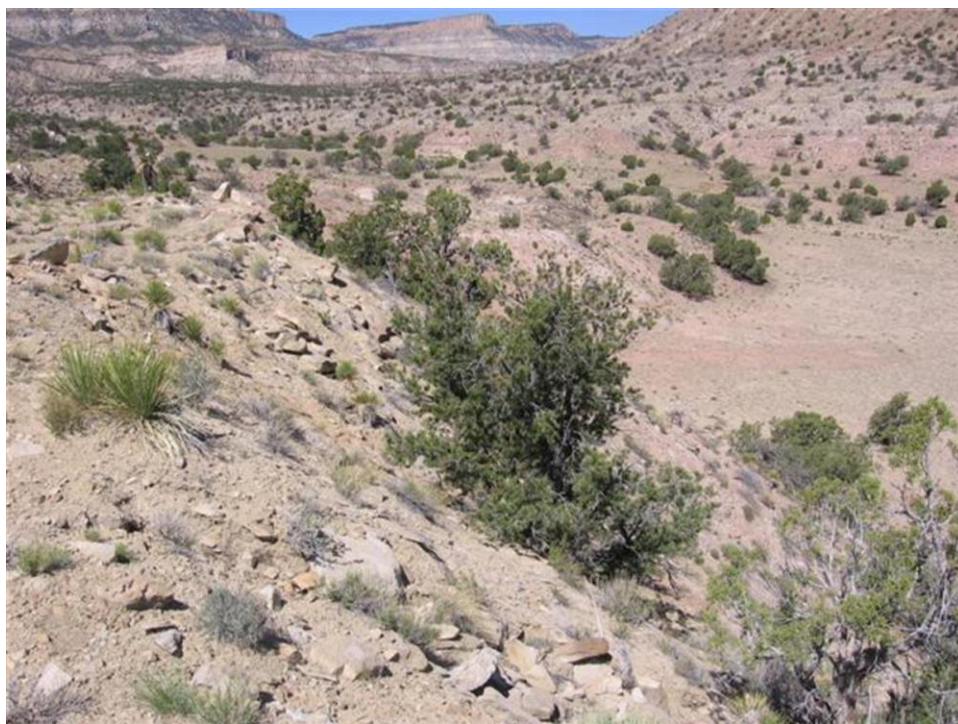
Photo 15: Mine Site #402; Tailings
